# Emission regimes of POPs of a Dutch incinerator: regulated, measured and hidden issues

Arkenbout, A, Olie K, Esbensen, KH

**DioXin 2018**

# 'State of the art' incinerator, NL

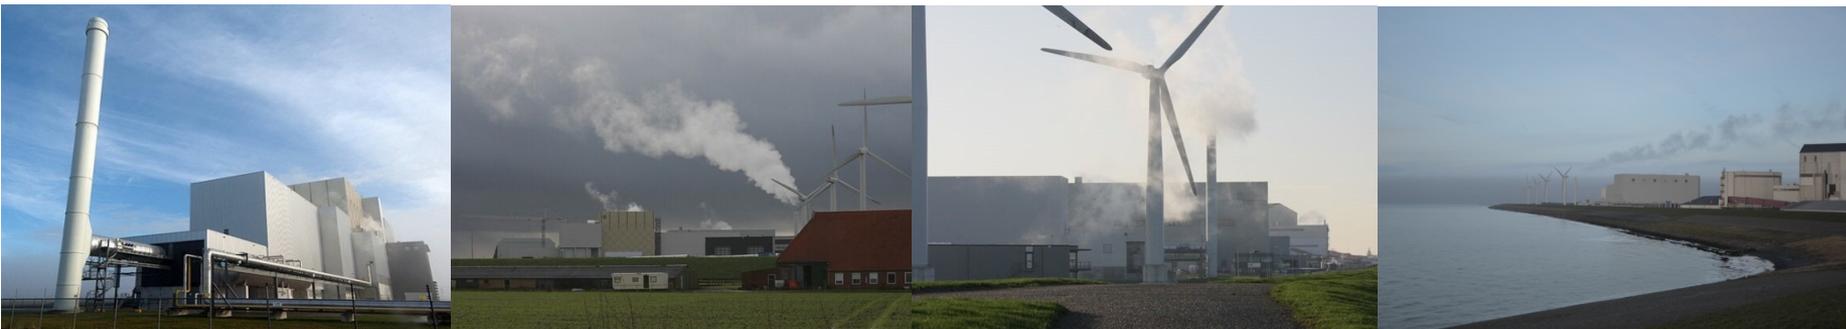
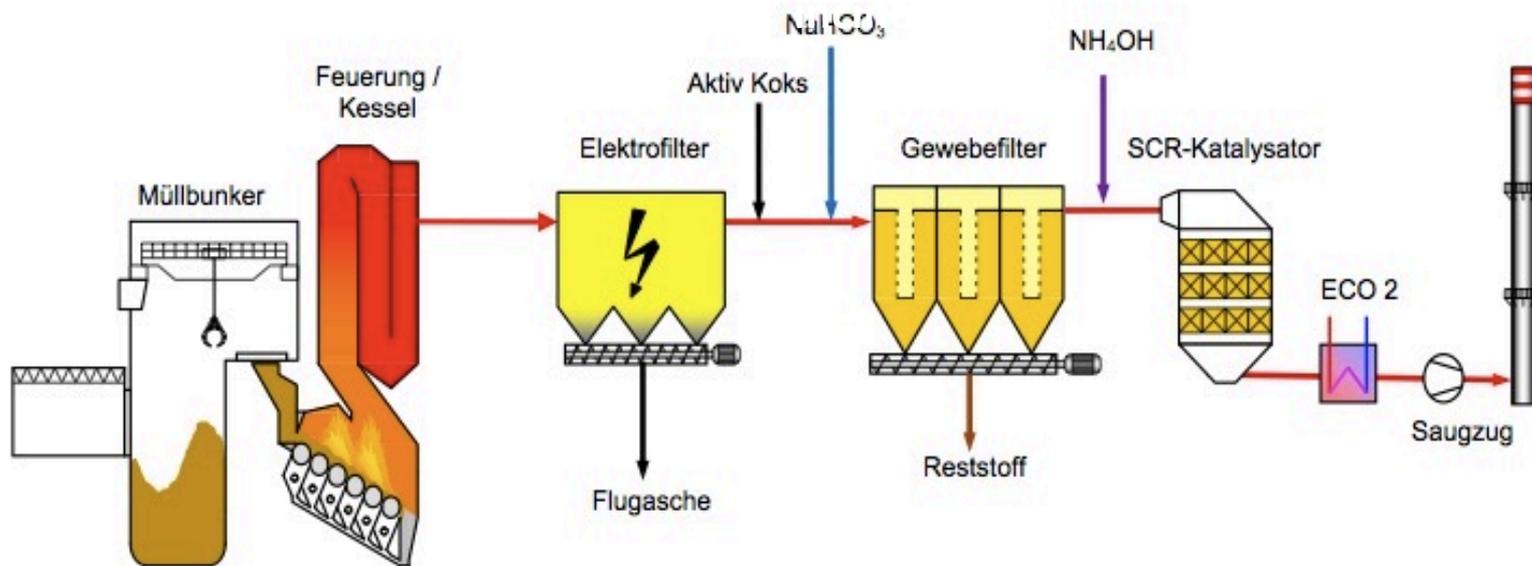
Best Available Techniques (BAT): Furnace, ESP, Fabric Filter, SCR katalysator

A more stringent permit of 0,01 ng TEQ/Nm<sup>3</sup> for dioxin emissions was given

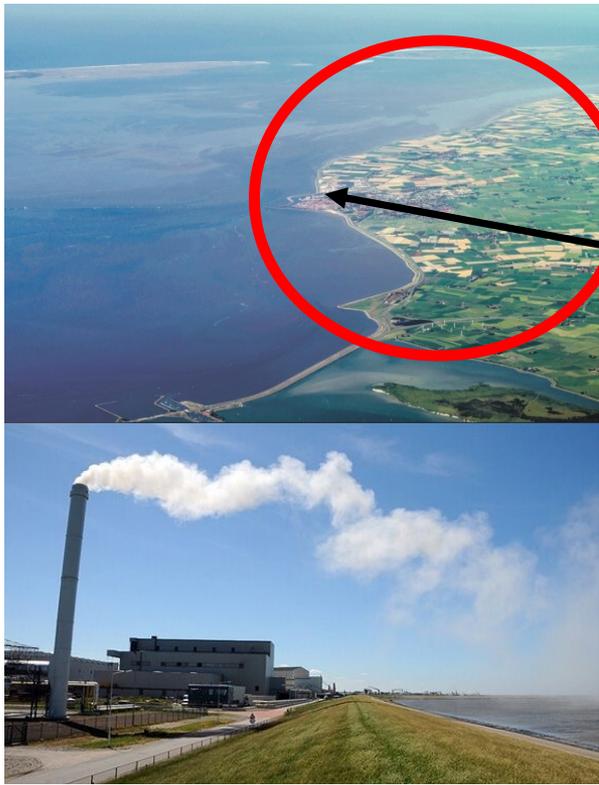
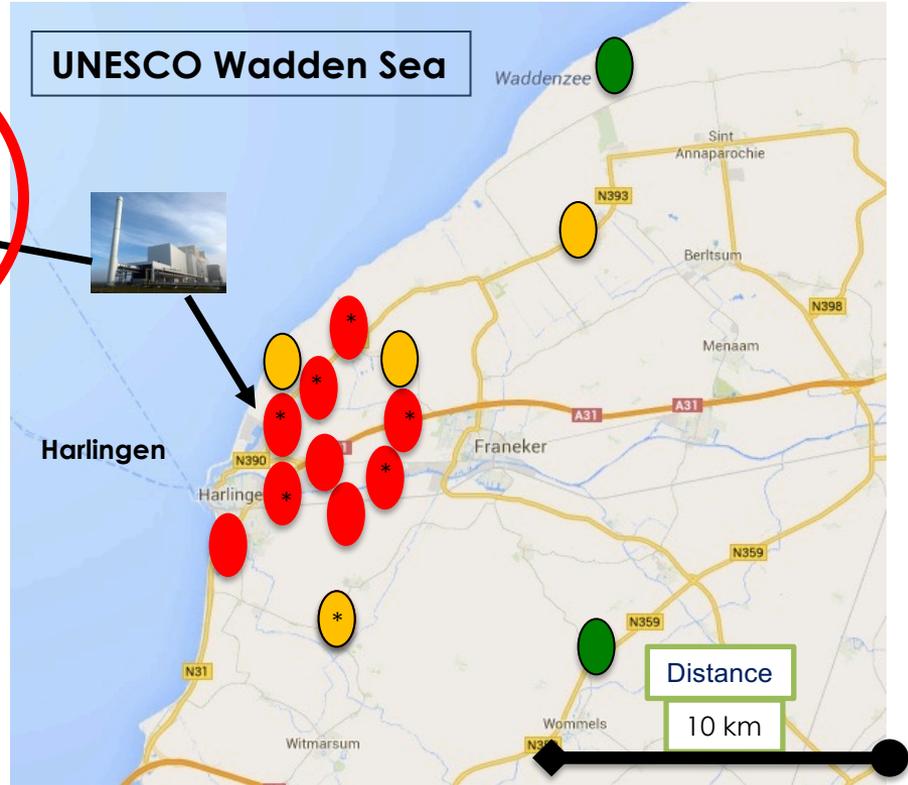
- DR CALUX®**
- > 3,4 pg BEQ /g fat
  - > 1,7 pg BEQ /g fat
  - < 1,7 pg BEQ /g fat
- T GC-MS**
- BEQ: Bioanalytical Equivalents**

ToxicoWatch research on eggs of backyard chicken shows contamination of dioxins in the environment of the incinerator

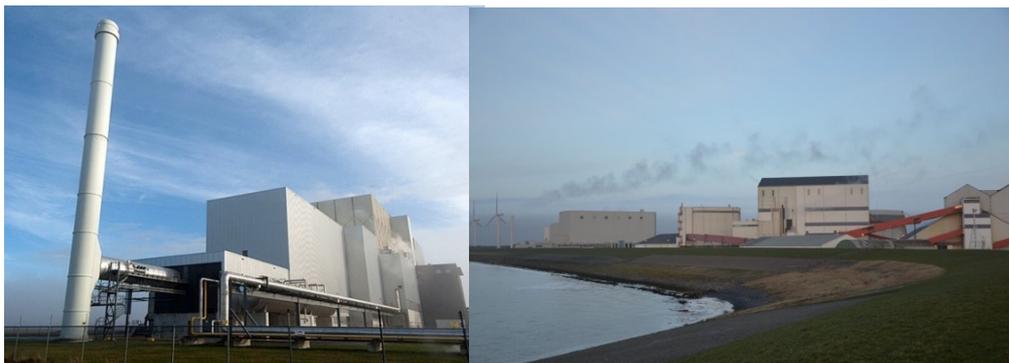
- 12 hours measurement period ( 2 x 6 hours)
- Only under steady state conditions\*
- Pre-announced

Sampling: 0,1 % of a year

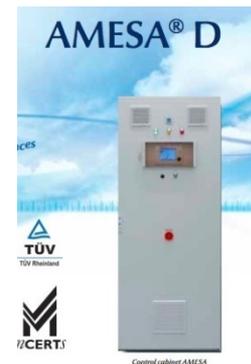
- Continuous sampling
- All conditions\*

Adsorption **M**ethod for **S**ampling of dioxins  
**AMESA**

uptime > 95 % a year

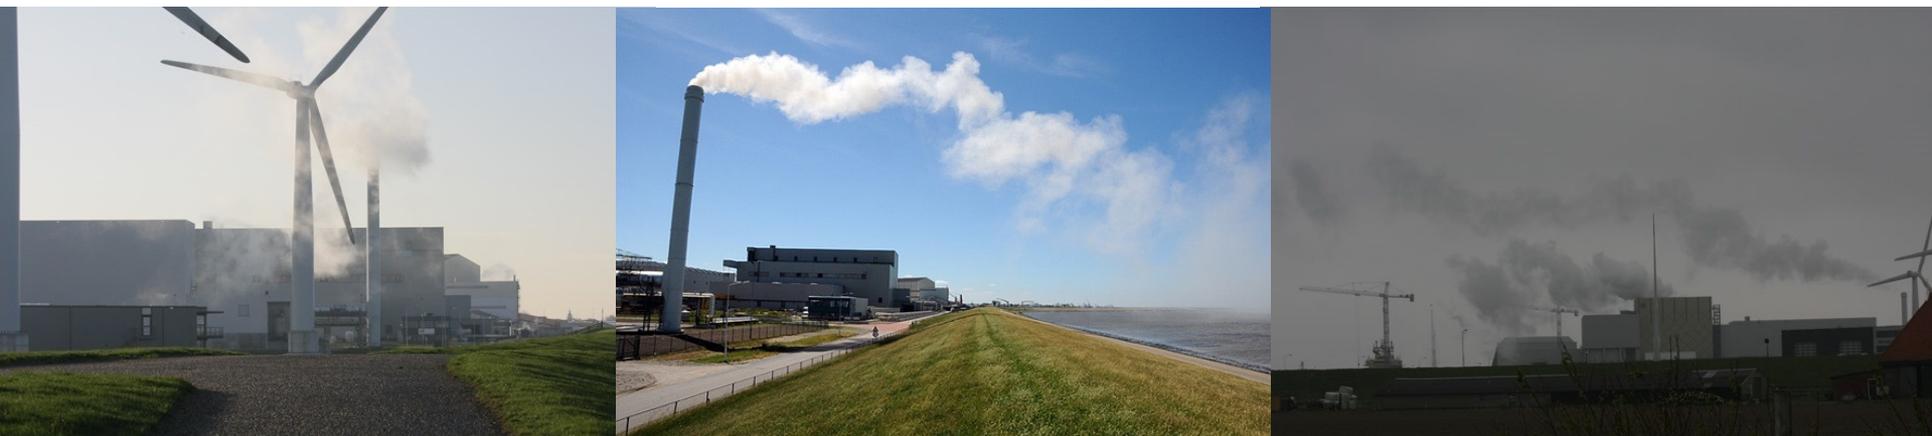
Sampling	hours	ng TEQ/Nm <sup>3</sup>	Factor
Short-term, March 30, 2016	6	<0,00001	
Long-term March 26– April 26, 2016	256	0,01290	>1290
Short-term, 8 March 2017	6	0,00001	
Long-term March 7 – April 5, 2017	690	0,00460	460

Sampling for official monitoring purposes must be *representative*.  
Short-term sampling *underestimating* emission dioxin levels.

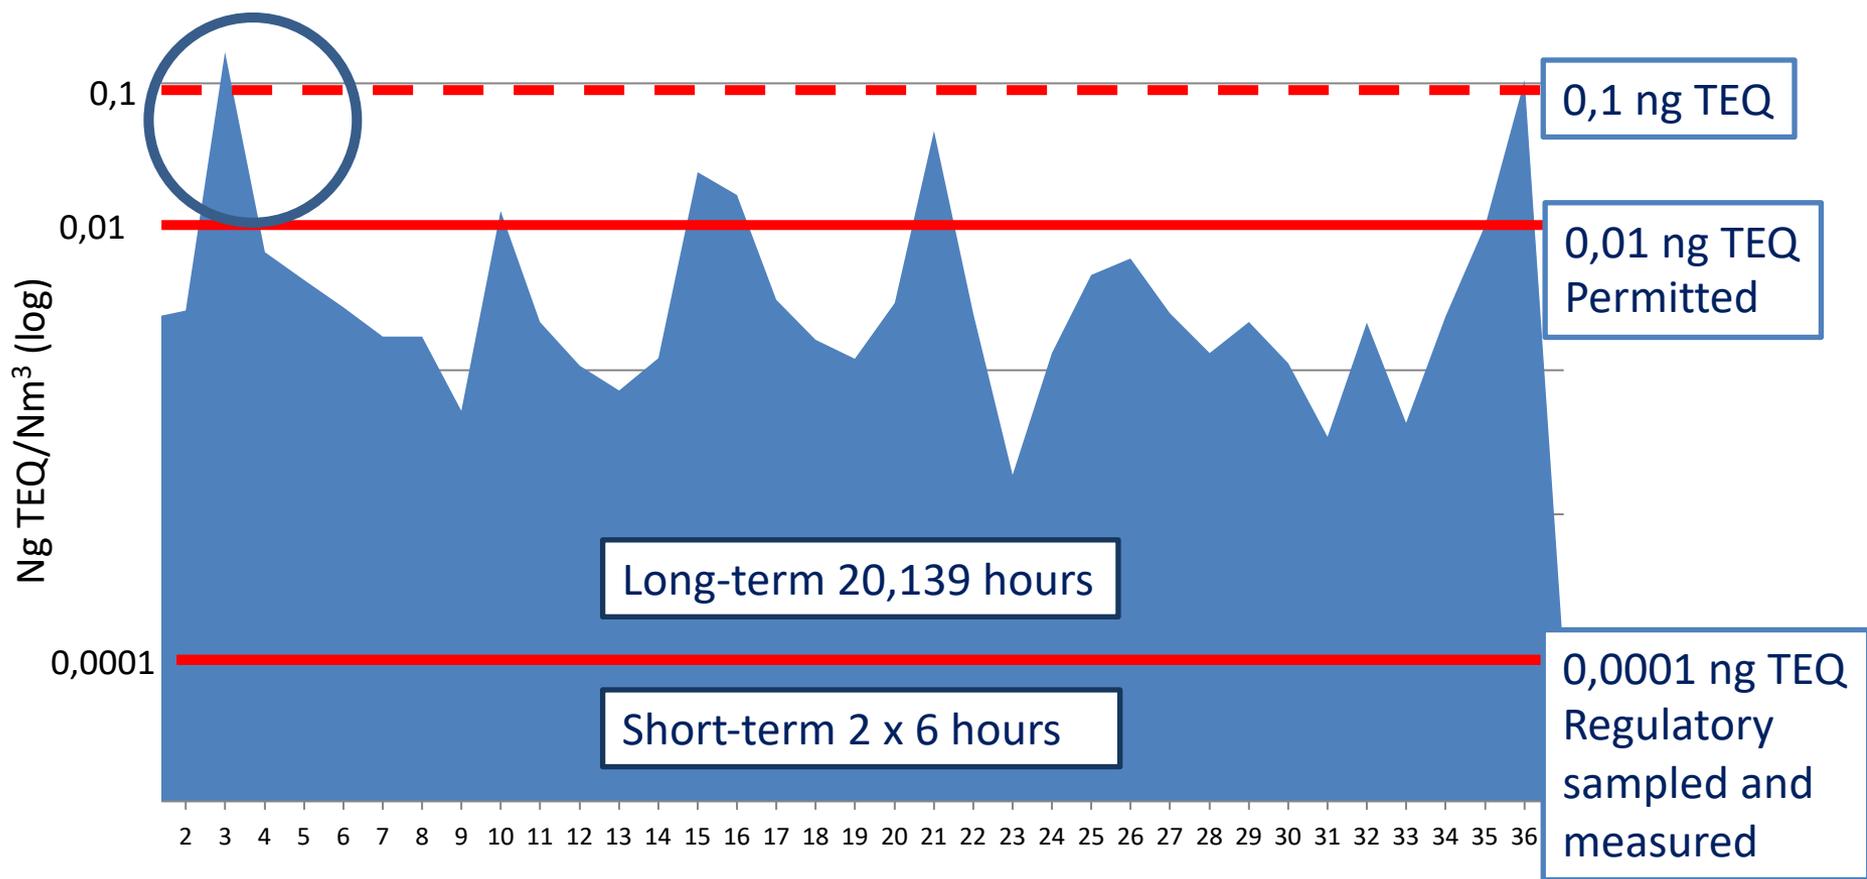
20,139 hours sampling of PCDD/Fs, Aug 2015 till May 2018

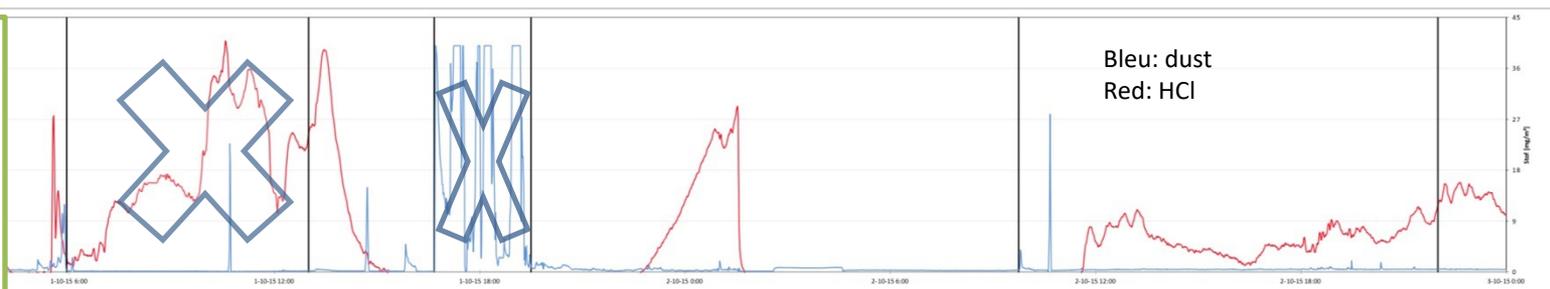
- Temperature
- Aux. Burners
- E-Filter
- Fabric Filter
- Active carbon
- AMESA

fase	normaal	A	B	C	D	E	normaal
proces-omstandigheden	korte trip ID fan om 05:21 uur; definitieve trip om 05:56 uur	afbranden afval op rooster	13:00 uur rooster leeg; blussen afval doseertafel tot 15:30 uur	spoelen installaties	opstart met gasbranders (geen afval)	toevoer afval	
settemp. [C] gem.	gemiddeld 982 °C	gemiddeld 611 °C	gemiddeld 441 °C	gem. 335 °C	gemiddeld 711 °C	gemiddeld 996 °C	1015 °C
steunbranders							
E-filter							
doekenfilter							
poederkool							
monstername	monster 2	uit tot 12 uur	monster 3	uit	monster 3	monster 3	mon. 3
tijd per fase		05:56 - 13:00	13:00 - 16:40	16:40 - 19:30	19:30 - 10:00	10:00 - 22:00	
uren per fase		7,0	3,6	3,0	14,5	12,0

**5 hours off: 'Fire-off' signal, uncontrolled burning of 19 ton undefined waste**

**3,5 hours off during flushing of dust (50-100 kg) with bypassing filters**

- Measured 0,17 ng/Nm<sup>3</sup> when fire was off and the system was 'cleaned'.
- Emissions of dioxins was more the measured 27 mg PCDD/F (annual emission REC 5,3 mg)
- Factor 5

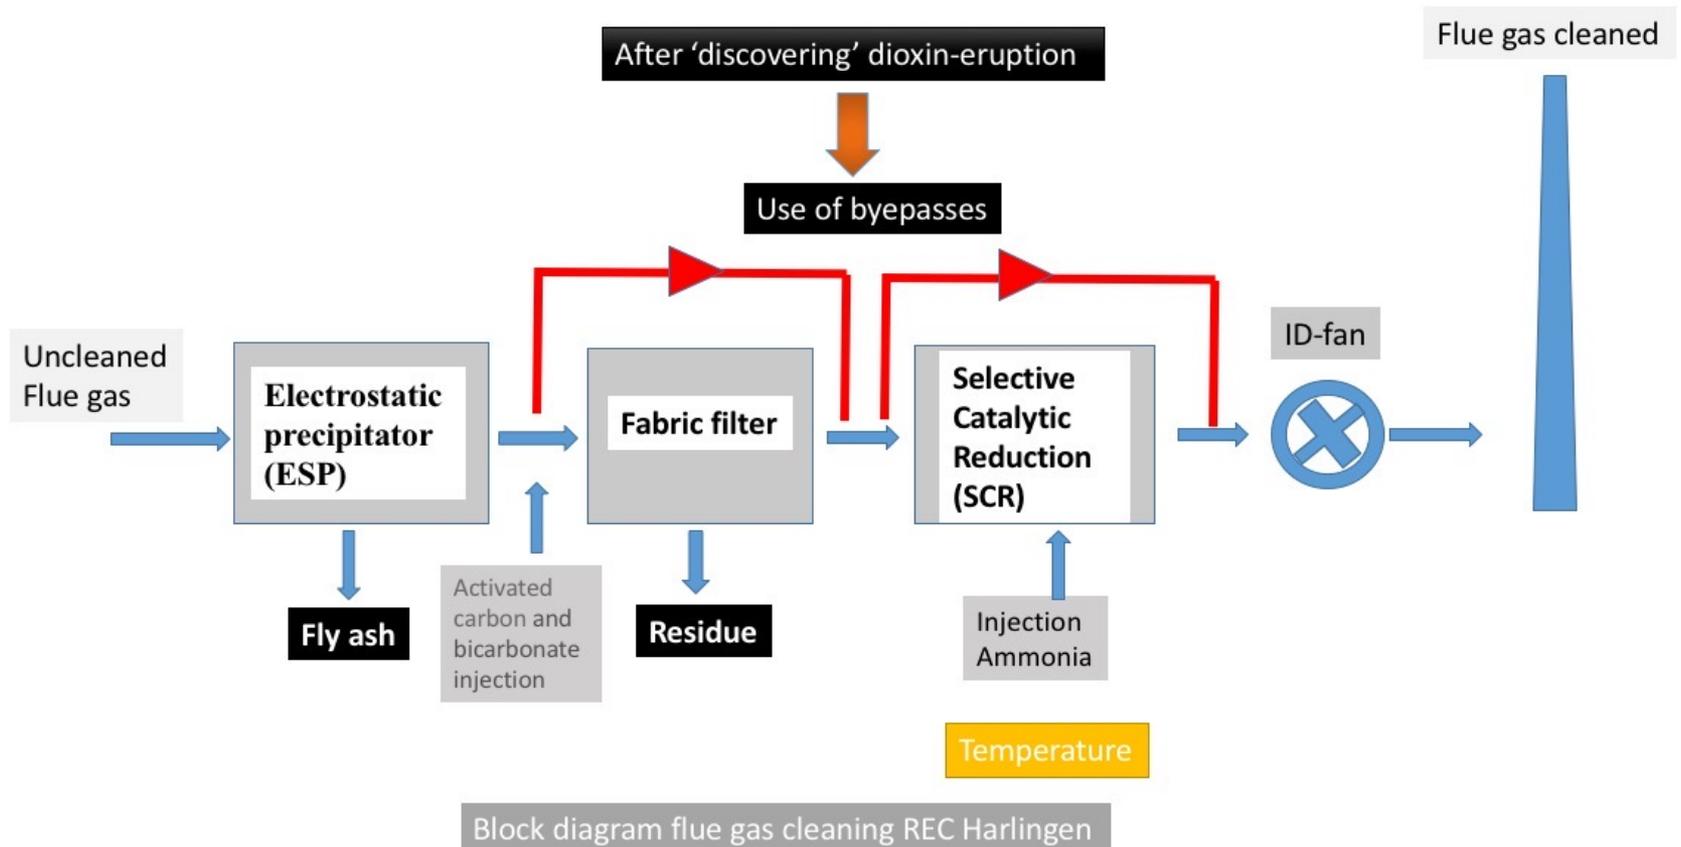
Commitment: stop use bypasses

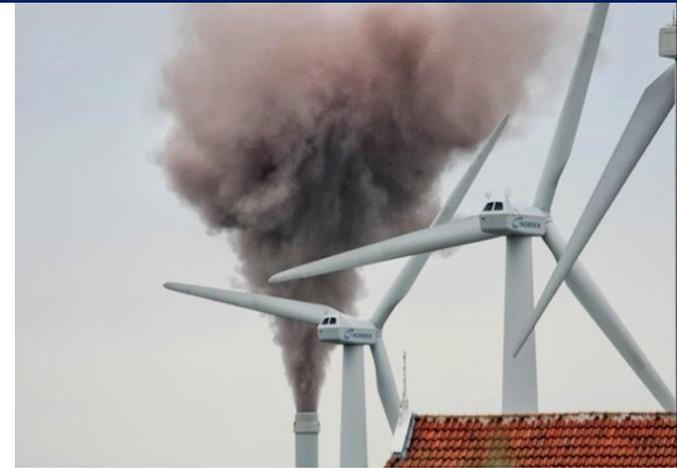
Phase 1	Pre-flushing
Phase 2	Flushing (cold)
Phase 3	Heating up
Phase 3B	Flushing (hot)
Phase 4	Starting waste feed
Phase 5	Regular operation

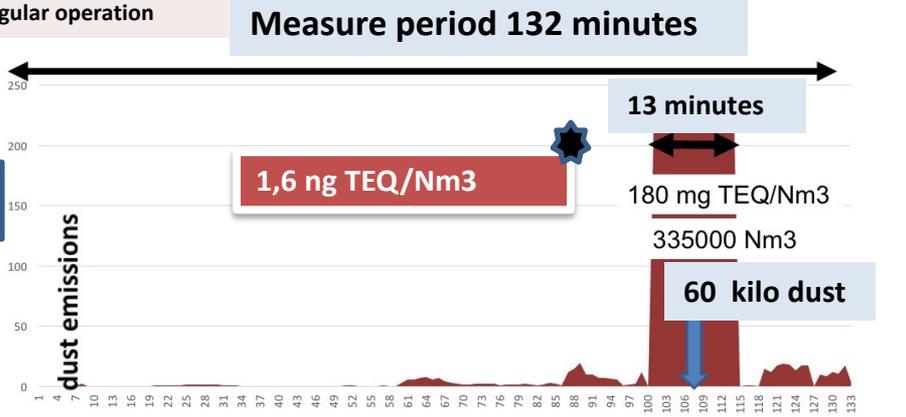
Phase 2

Total dust 2016: 759 kg (REC)

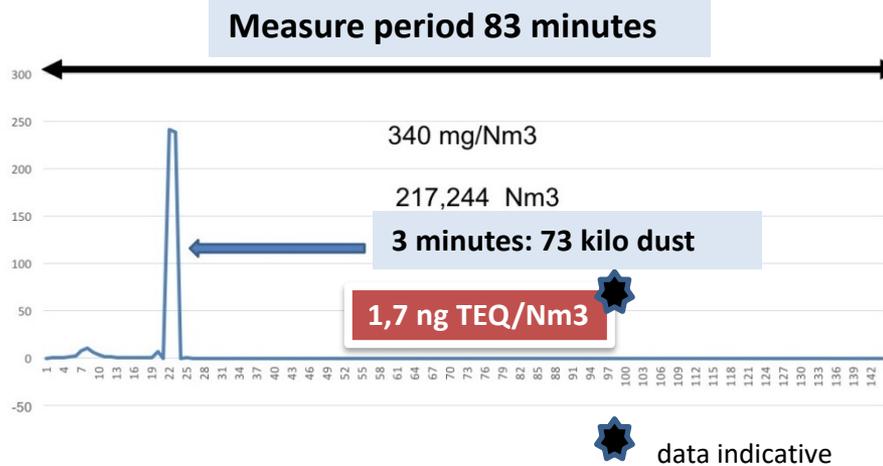
Phase 2

Total dust 2017: 222 kg (REC)

*'Chasing dust emission',  
 Only a few minutes*

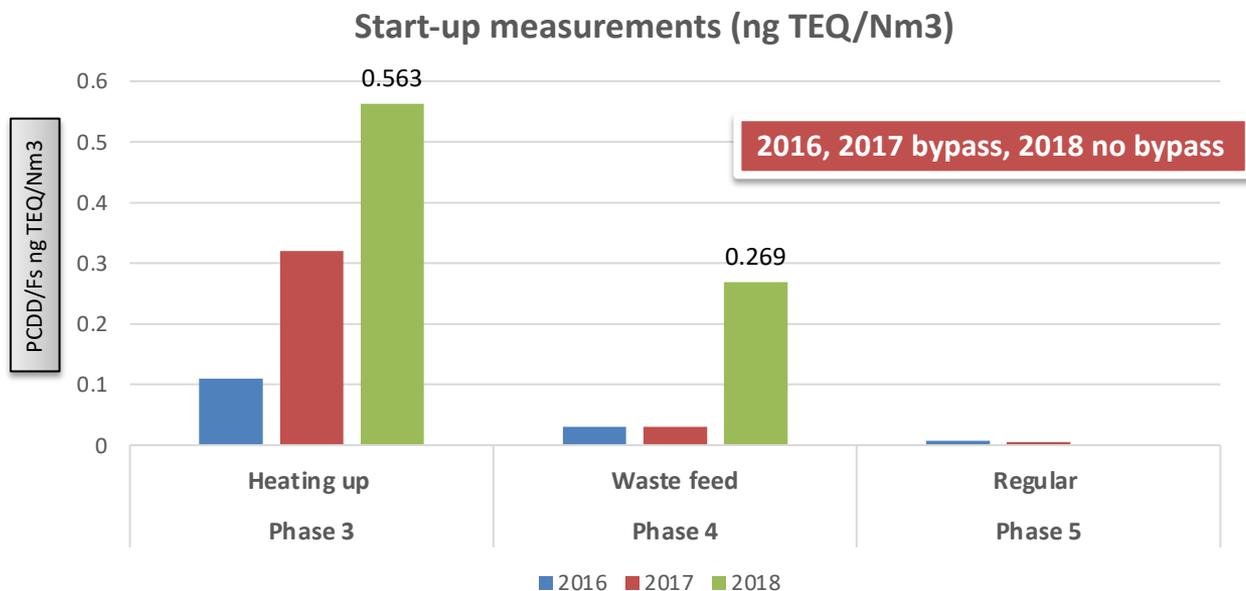
2016 1,6 ng TEQ/Nm<sup>3</sup>

2017 1,7 ng TEQ/Nm<sup>3</sup>

Parallel research by Odra and EML (Not AMESA)

**2018: NO improvement in dioxin reduction**

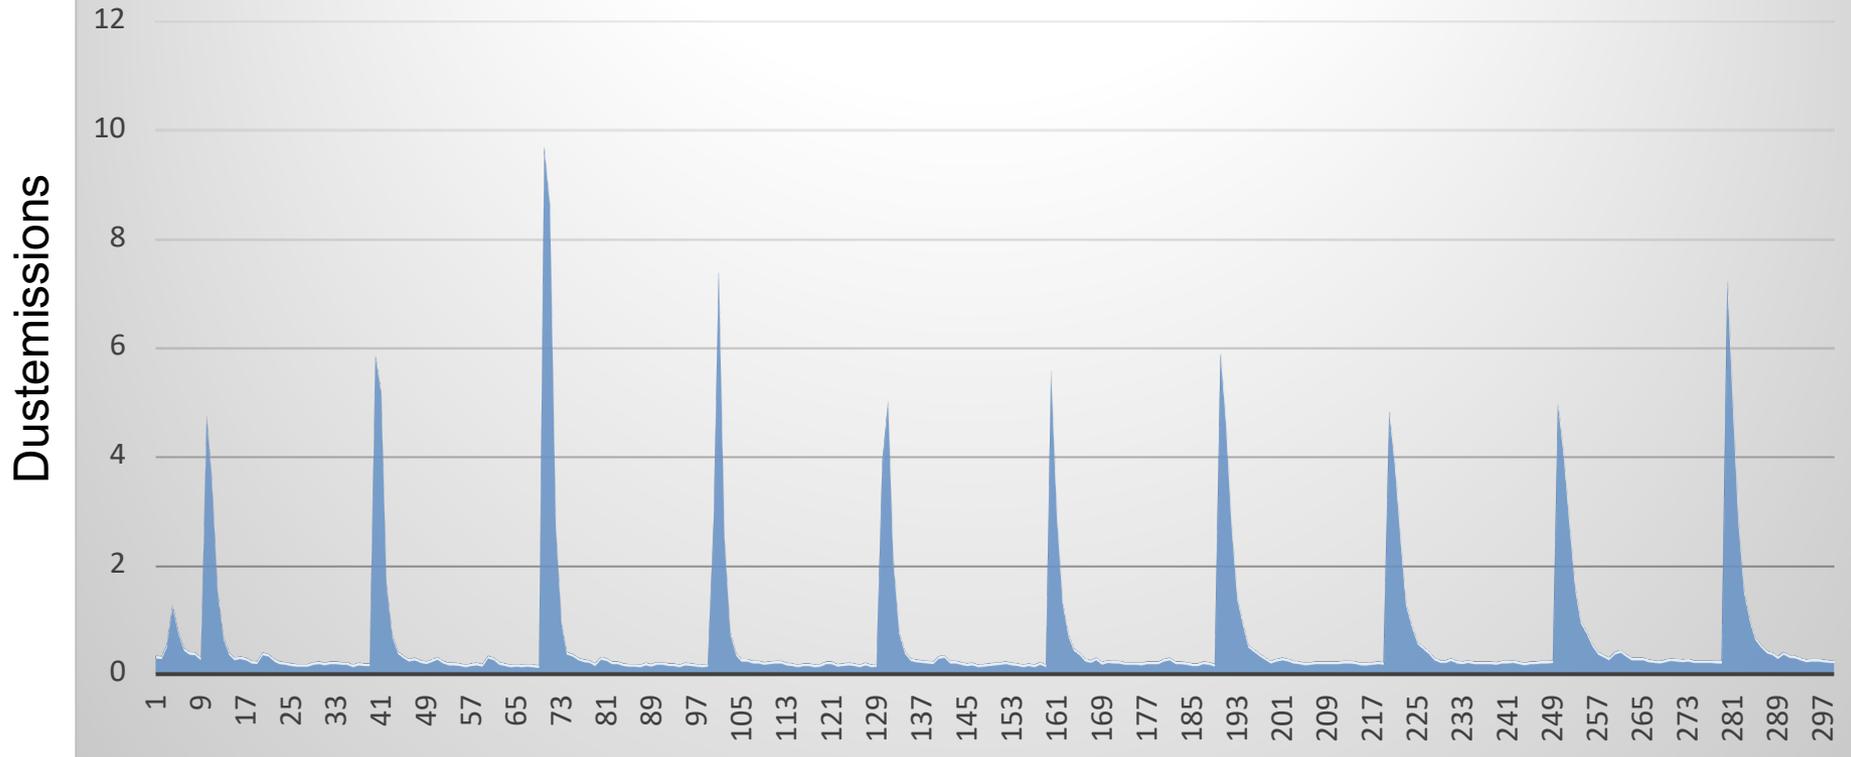
Pattern 21-4-2016, every peak is 3 minutes dust

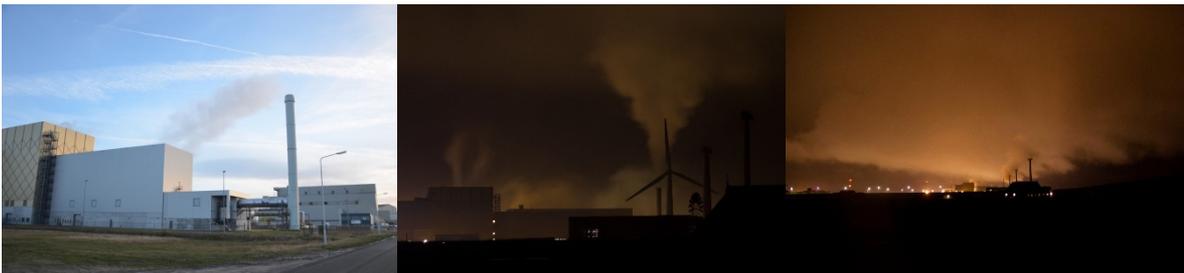
Most of the time, bypassing (dump stacks) takes only a few minutes

Night-shifts

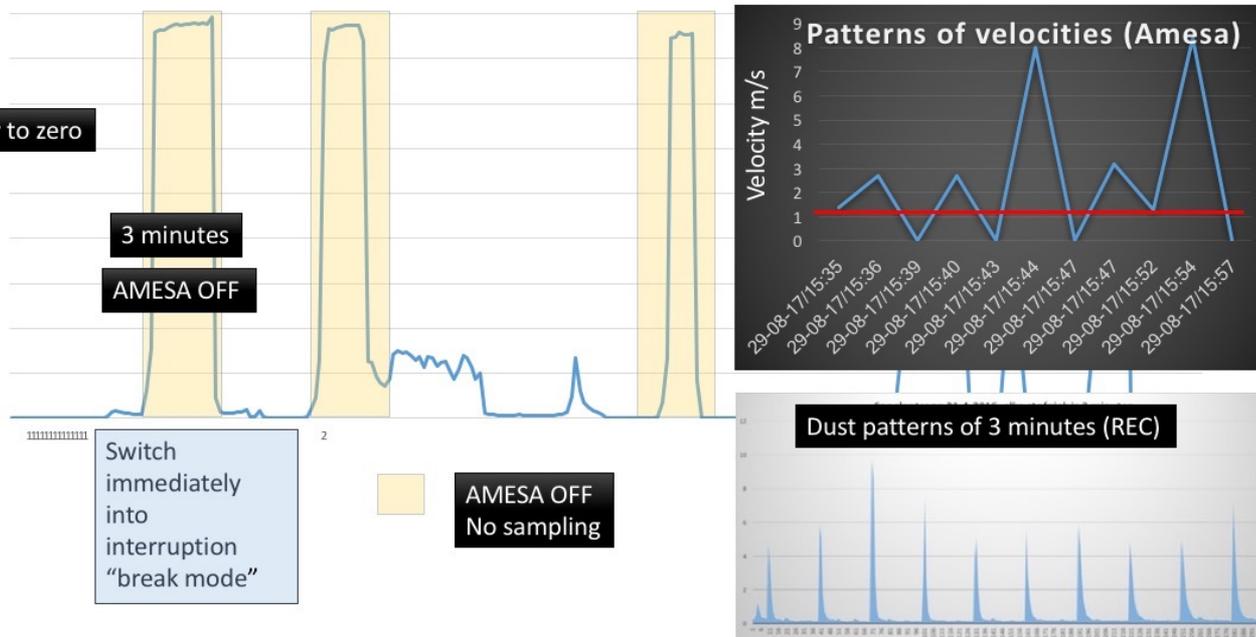
### Patterns VH<VHUGR

When velocity comes under the level of 1,5 m/s, sampling stops.  
 When velocity comes above the level of 1,5 m/s, it takes 3 minutes to start sampling again  
 Also when this happens within a minute

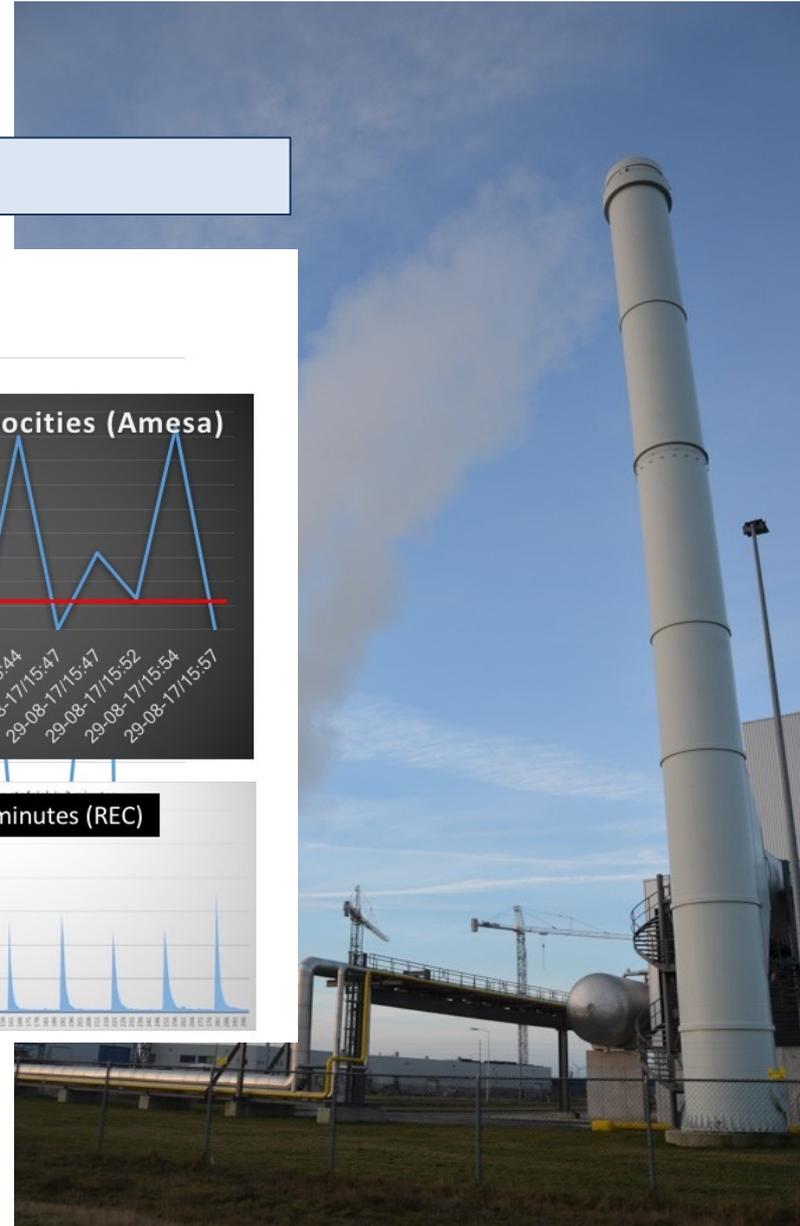
## Leakage test AMESA after VH<VHUGR)

These codes causes a stop of sampling in the AMESA cartridge  
After a leakage test of 3 minutes, sampling starts again

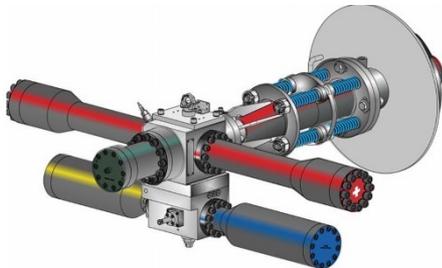
SMART Explosion

Shock Pulse Generator

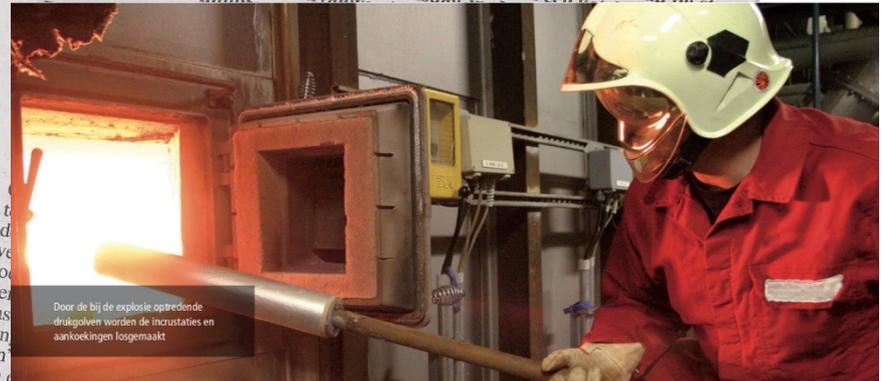
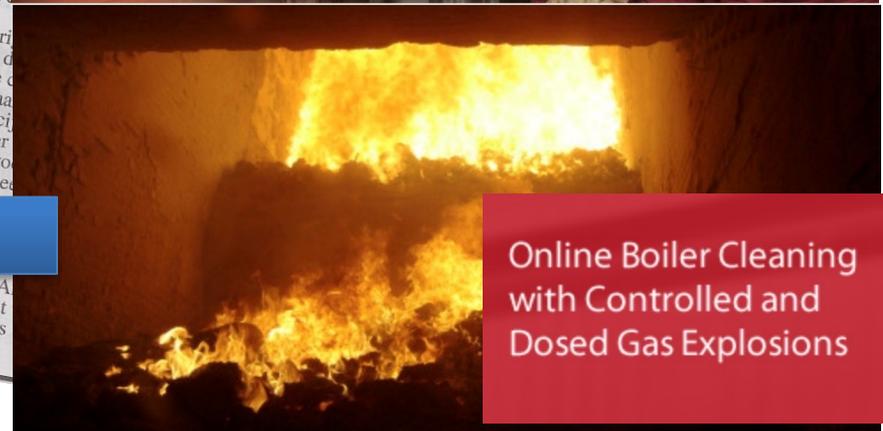
Door de bij de explosie optredende drukgolven worden de incrustaties en aankoelingen losgemaakt

Online Boiler Cleaning  
with Controlled and  
Dosed Gas Explosions

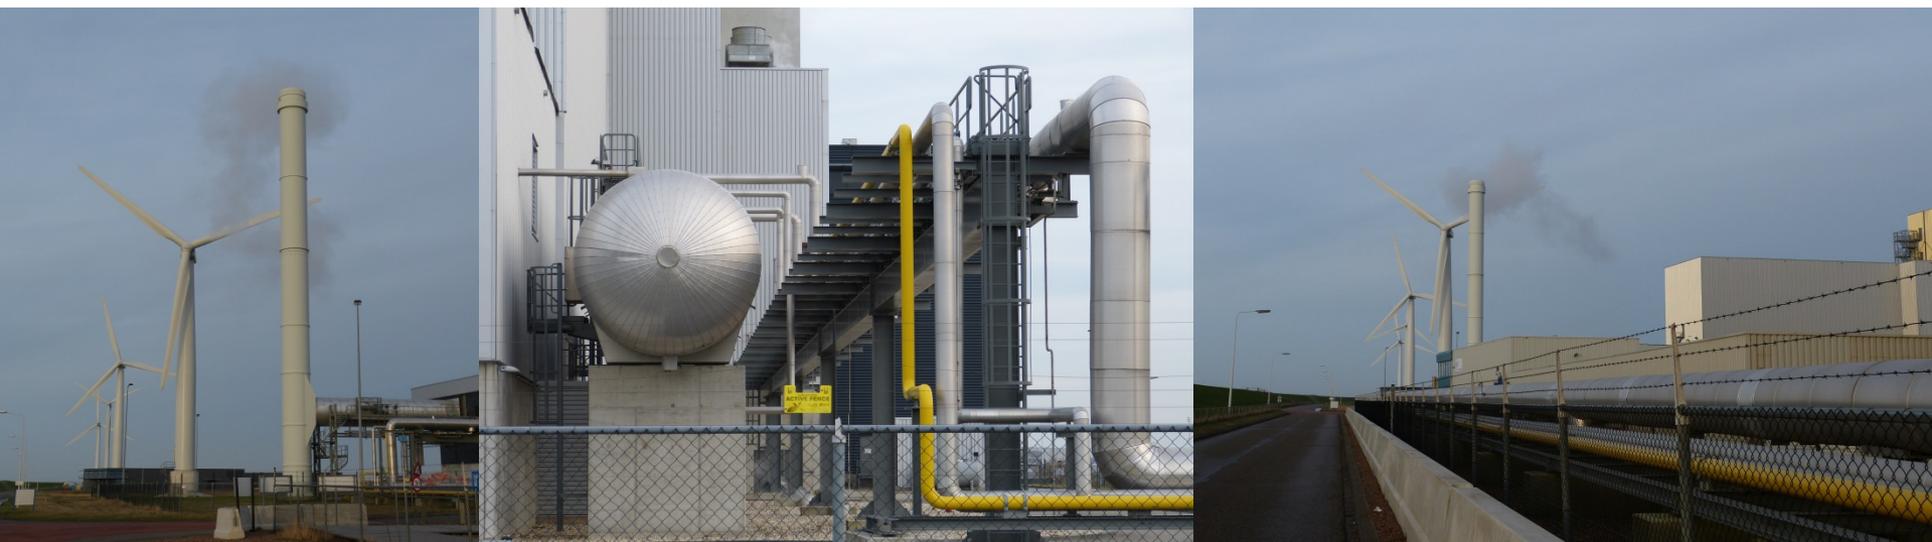
2018: Performed only 31% because of sample break (VH < VHUGR).

AMESA only sampling after the dump-stacks of dust.

**Data AMESA during start-ups are therefore incomplete, gravimetric measurements confirm this.**

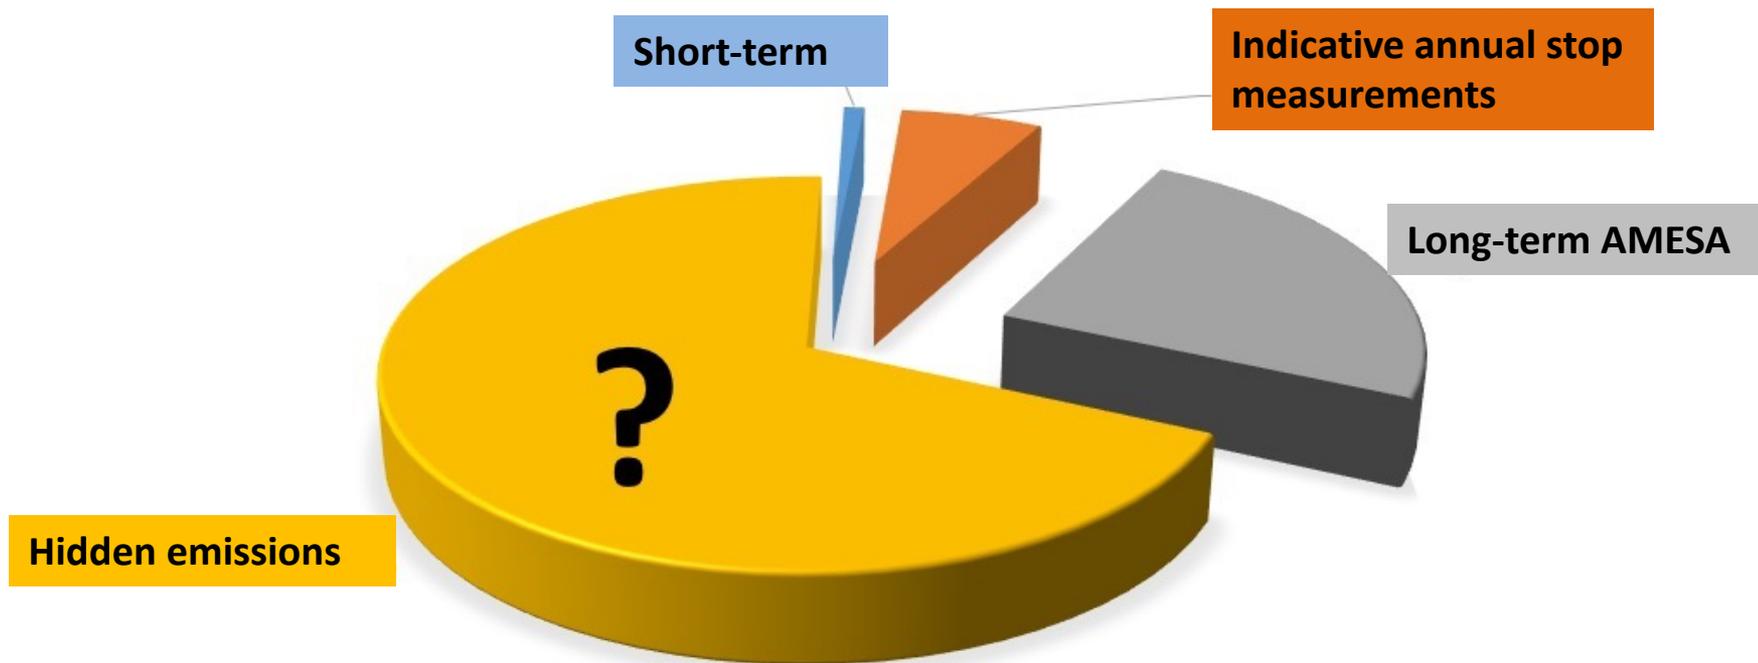
## Hidden dioxin emissions

AMESA stops, but leaving many questions have arisen...
